European Patent Office

Fire Safety main building (EPO II)

Introduction EPO II

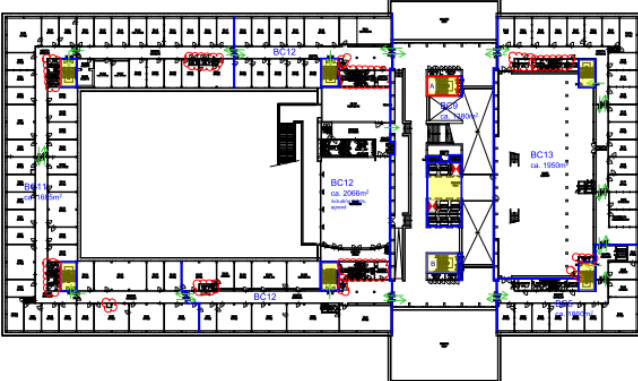
Fire safety concept

aangepast brandveiligheidsconcept
 behorende bij DGMR-notitie
 F.2010.1366.01.N001 d.d. 13-09-2011

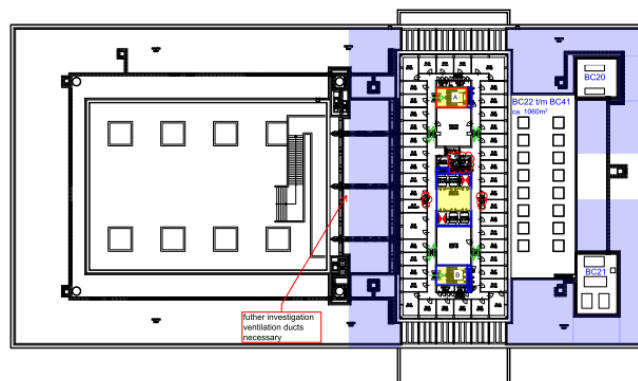
aangepast brandveiligheidsconcept
 behorende bij DGMR-notitie
 F.2010.1366.01.N001 d.d. 13-09-2011
